# **K+DCAN USB Interface**

## **Application Note**

# **Connection Stability**

**( On DCAN equipped Vehicles )**

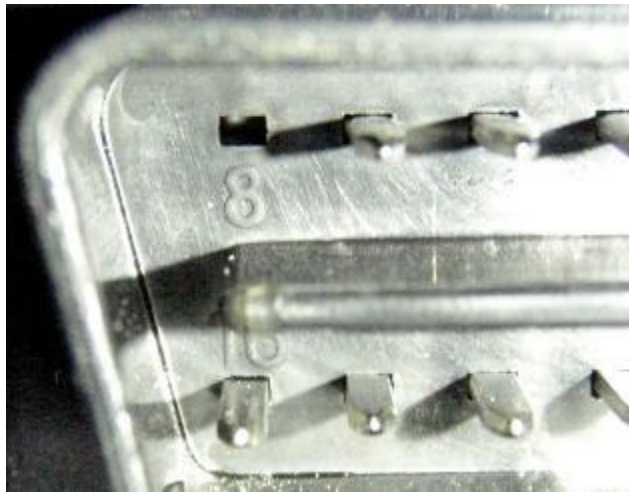
**Close-UP Picture of an Interface with pin8 removed:  
(Second Generation)**

**Because most customers prefer the ability to work on latest DCAN equipped vehicles over the full backward compatibility to older K-Line equipped vehicles - pin8 was physically removed from the Interface to enable that. The consequence from that step is that when used in backward compatibility mode on older K-Line equipped vehicles that the Interface now only covers modules (ECUs) connected to the primary K-Line on pin7. Modules (ECUs) connected to the secondary K-Line on pin8 will no longer be directly accessible.**

- You did not set the latency of the driver from the default 16 msec. to 1 msec. and therefore your connection times out if the USB data packet cannot be filled within the timeout required by the software you use, please refer to the Driver Installation Manual for more details about how to set the Latency to 1 msec.**
- You work on a pretty new DCAN equipped vehicle such as the F Series with a cable that got pin8 still installed for backward compatibility to older K-Line equipped vehicles, remove pin8 for example by de-soldering it from the OBD2 header PCB. (You will have to open the Interface for that, this operation if done properly does not affect the warranty of the product)**

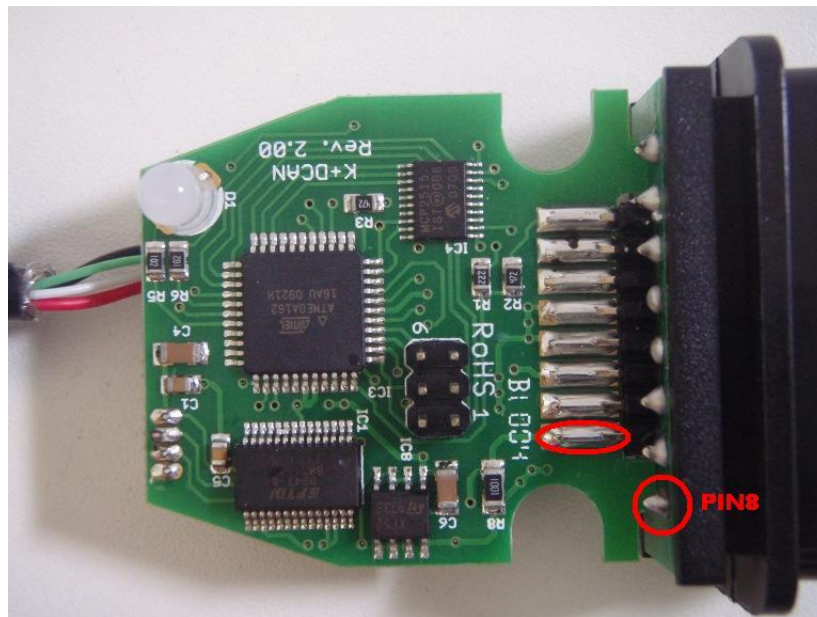
**Another view on the complete PCB:**
